## **Road Condition Monitoring of Major and Minor Route in Part of Ibadan Metropolis Using Geo-spatial Approach**

**Original Research Article**

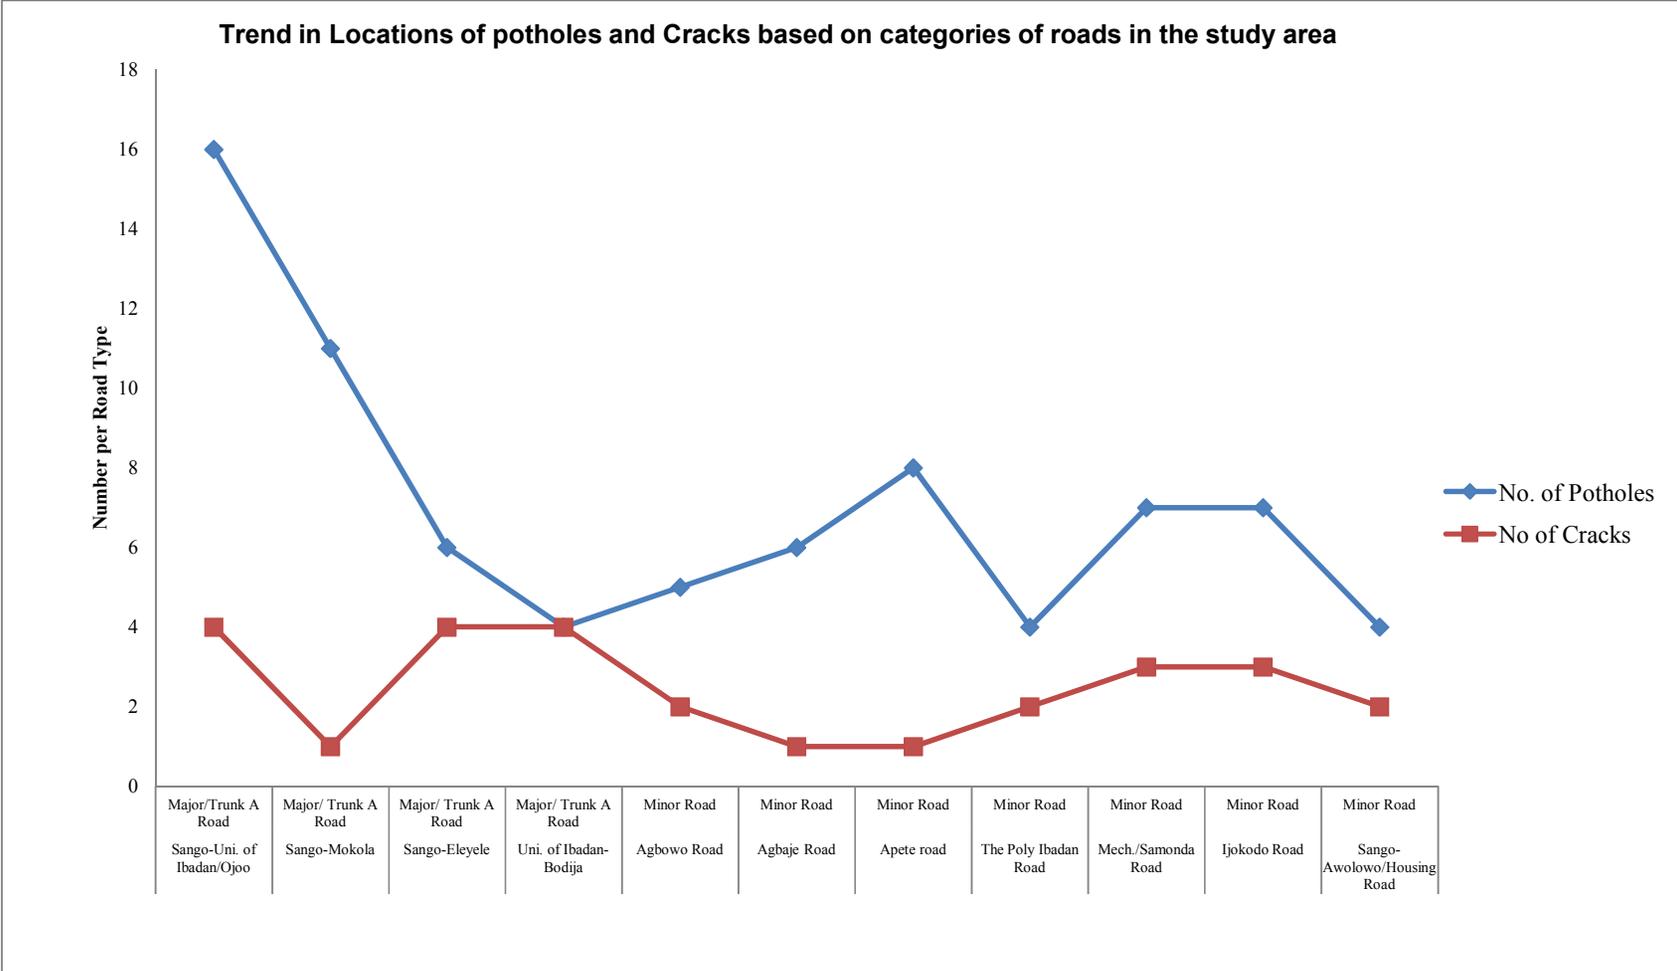
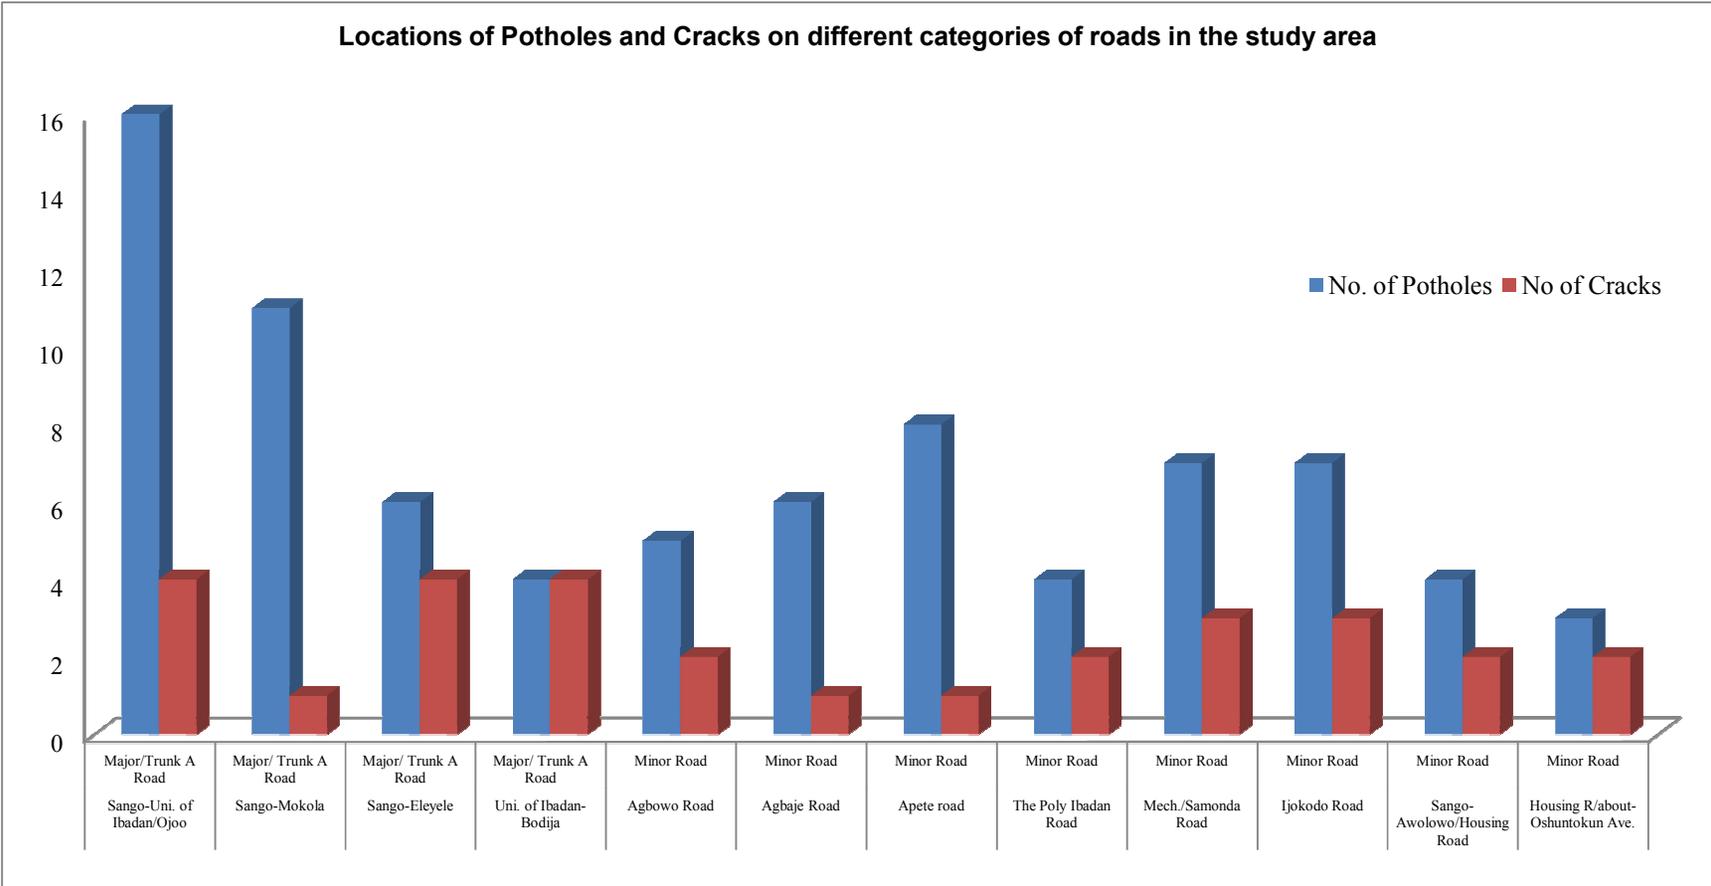
From Table 3, it can be deduced that the road network from Ojoo/University of Ibadan-Sango has the highest number of potholes followed by that of Sango-Mokola road. Thirty-seven (37) representing 45.68% number of potholes are on the major roads while forty-four (44) representing 53.32% number of potholes on minor roads while thirteen (13) representing 44.83% number of cracks are on major road and sixteen (16) representing 55.17% number of cracks on minor road which can be traced to the daily activities such as movement of vehicles, heavy carriage trucks and other road transport medium which occur on daily bases, material used by the road construction companies such as the soil type etc.

Fig. 4. Location of potholes and cracks in the study area

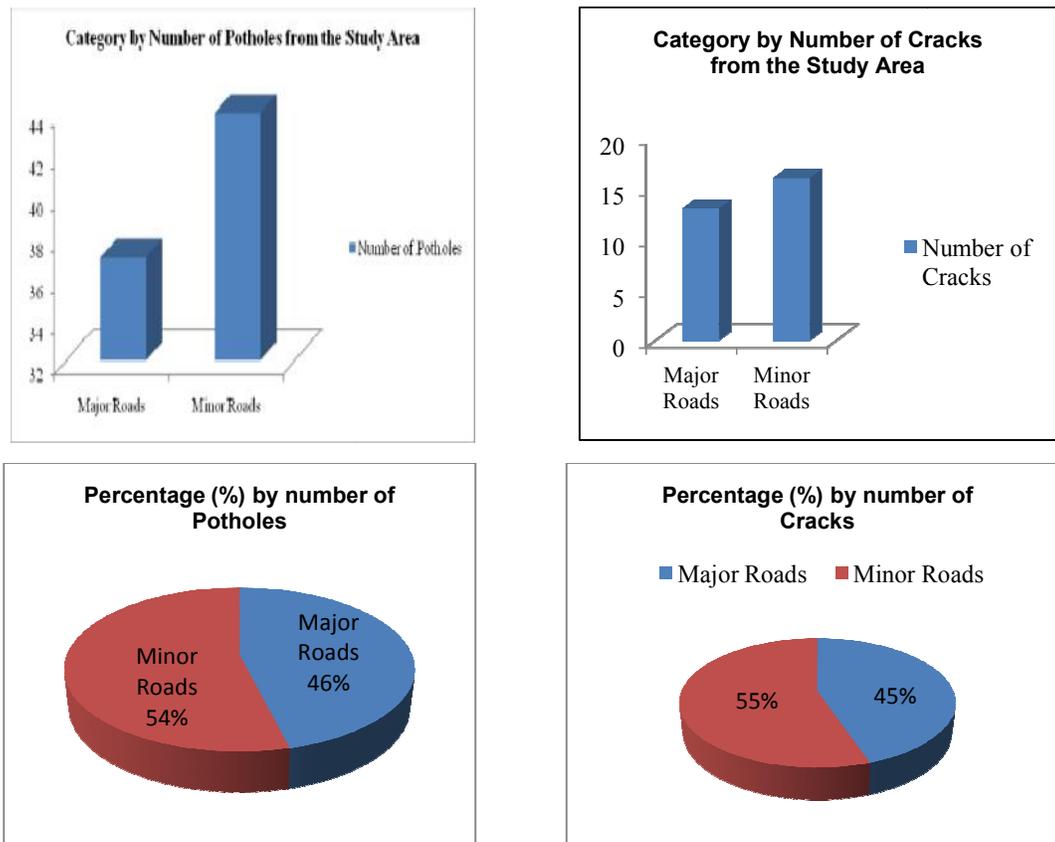
From Figs. 5, it shows that minor roads are besieged with a large number of potholes and cracks, followed by major roads. However, the reasons for this may be attributed to the type of construction firm, compartment of the underlaid soil before putting asphalt, poor drainage system, low-quality material during construction and failure to repair the road at the specified period.

Fig. 5. Shows different road classes and the percentage of potholes

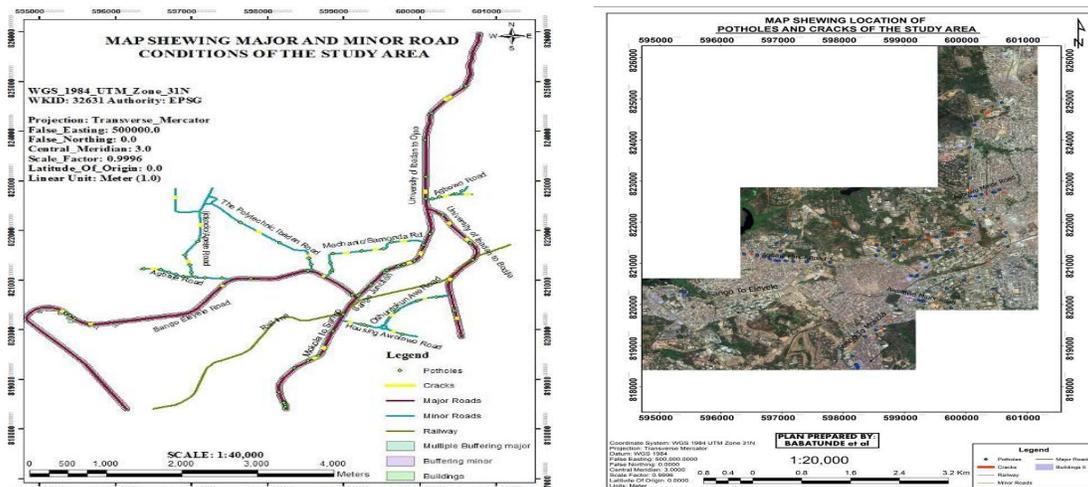
From the Table 6, the minimum and maximum length and depth of pothole range from 0.04-1.64 m, 0.05-0.89 m and crack minimum and maximum length and width range 0.17-0.88 m, 0.20-0.82 m which implies that the road is the fair condition. Therefore, all the affected areas should be renovated to avoid expansion of the affected parts.

Fig. 6. Plan showing location of potholes and cracks on major and minor roads

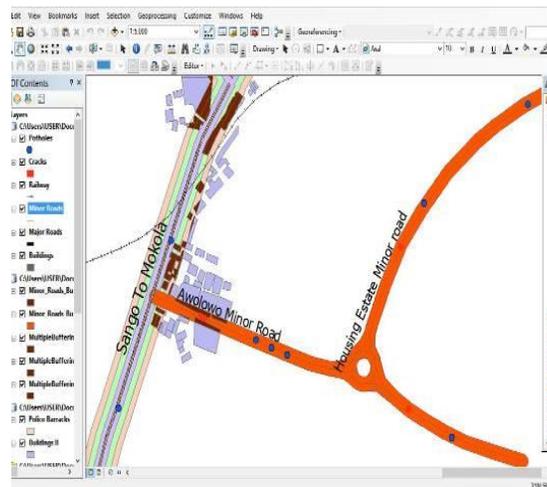
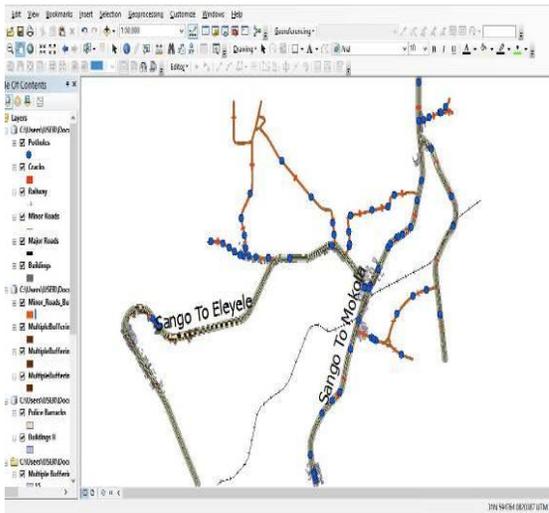
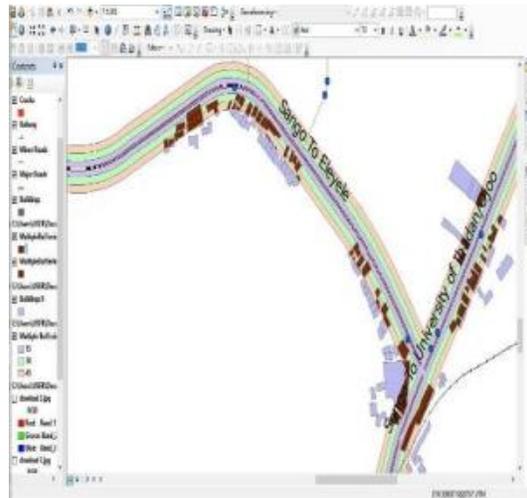
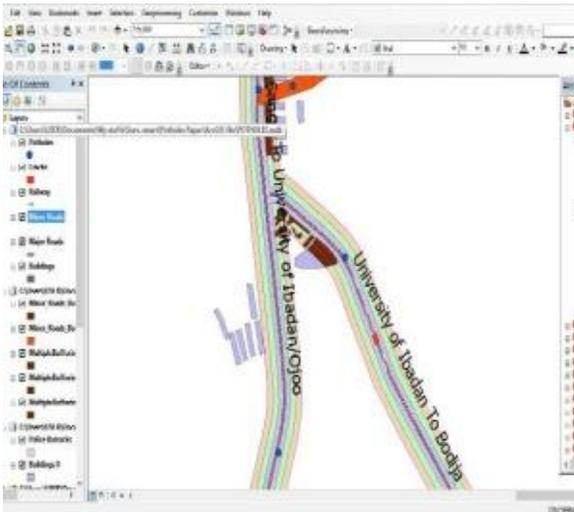
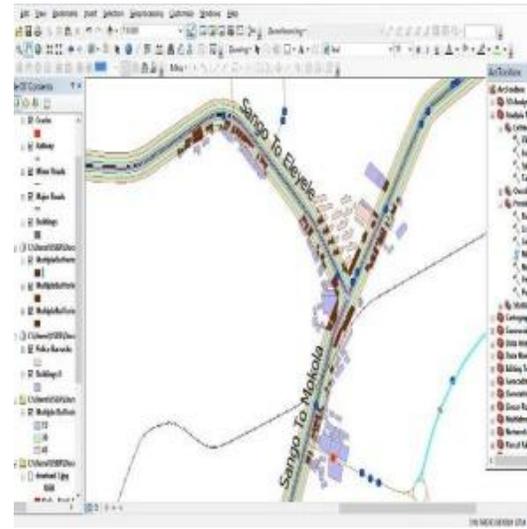
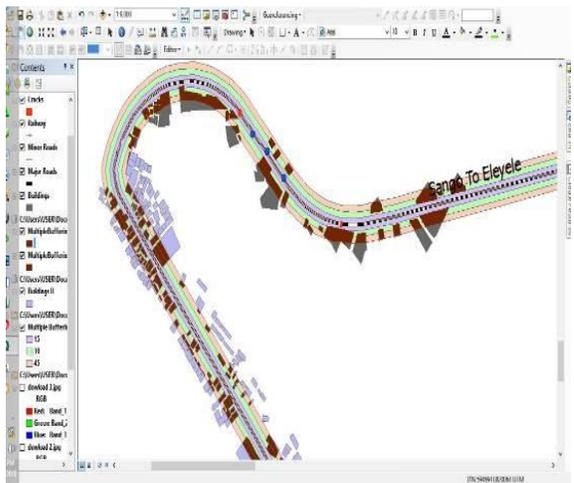
Fig. 7 showed multiple buffering rings of 15m interval and buffering features within and beyond the specified right of way along the route of the study area. The area with purple accent colour shows those features within 45m right of way, the area with colour olive green are the features within 30 m right of way while the area with an orange accent colour is the features that are within 15 m distance.

The features along the major roads were buffered regarding the specified right of way which is 30 m (98.42 ft) standard distance from the Centre of the road. From the result in Fig. 7, it showed clearly that at 45 m distance, 92% of

the features falls along the roads, at 30 m distance which is the required specification for the setback in oyo state, 85% of the features fall along the right of way and at 15 m distance about from the centre of the road, 95% of the features

fall outside the specified right of way. From the result and analysis, it showed that the specified right of way is not strictly followed by individuals and corporate organizations which may lead to loss of life and properties within the study area.

Fig. 7. Multiple buffering of major and minor roads in the study area
