## **Road Condition Monitoring of Major and Minor Route in Part of Ibadan Metropolis Using Geo-spatial Approach**

**Original Research Article**

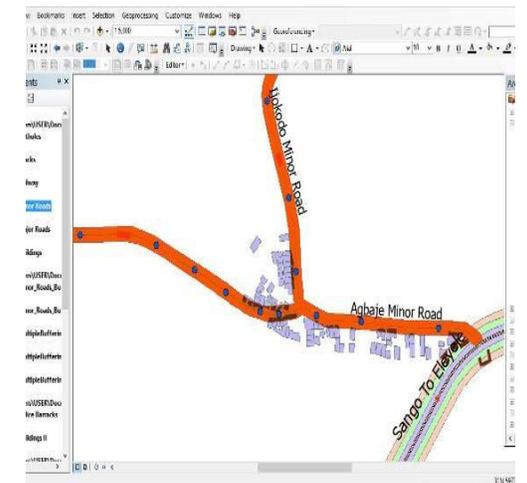
Fig. 7. Multiple buffering of major and minor roads in the study area

Fig. 7 showed multiple buffering rings of 15m interval and buffering features within and beyond the specified right of way along the route of the study area. The area with purple accent colour shows those features within 45m right of way, the area with colour olive green are the features within 30 m right of way while the area with an orange accent colour is the features that are within 15 m distance.

The features along the major roads were buffered regarding the specified right of way which is 30 m (98.42 ft) standard distance from the Centre of the road. From the result in Fig. 7, it showed clearly that at 45 m distance, 92% of

the features falls along the roads, at 30 m distance which is the required specification for the setback in oyo state, 85% of the features fall along the right of way and at 15 m distance about from the centre of the road, 95% of the features

fall outside the specified right of way. From the result and analysis, it showed that the specified right of way is not strictly followed by individuals and corporate organizations which may lead to loss of life and properties within the study area.
